Flying High

A Florida contractor uses a thermoforming PVC alloy pipe to reline culverts without disrupting heavy traffic on a naval air base

By Scottie Dayton

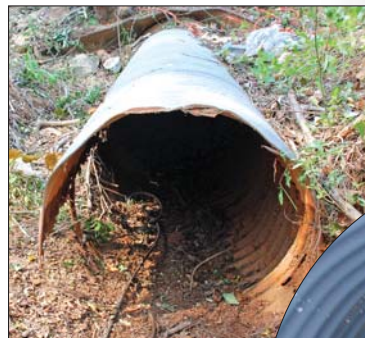
This culvert beneath a road had deteriorated badly.

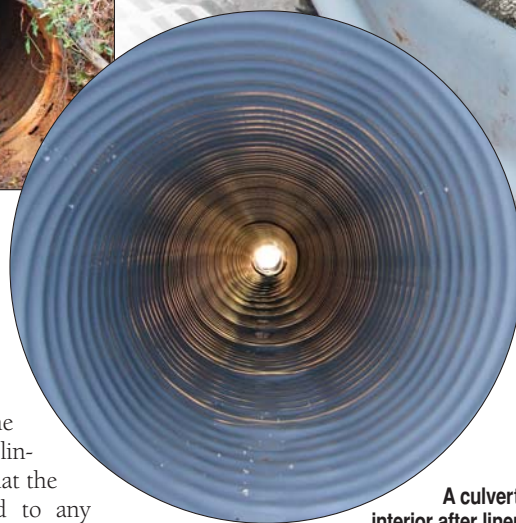
A culvert interior after liner installation. The liner fits so tightly against the host pipe that corrugation ripples are visible.

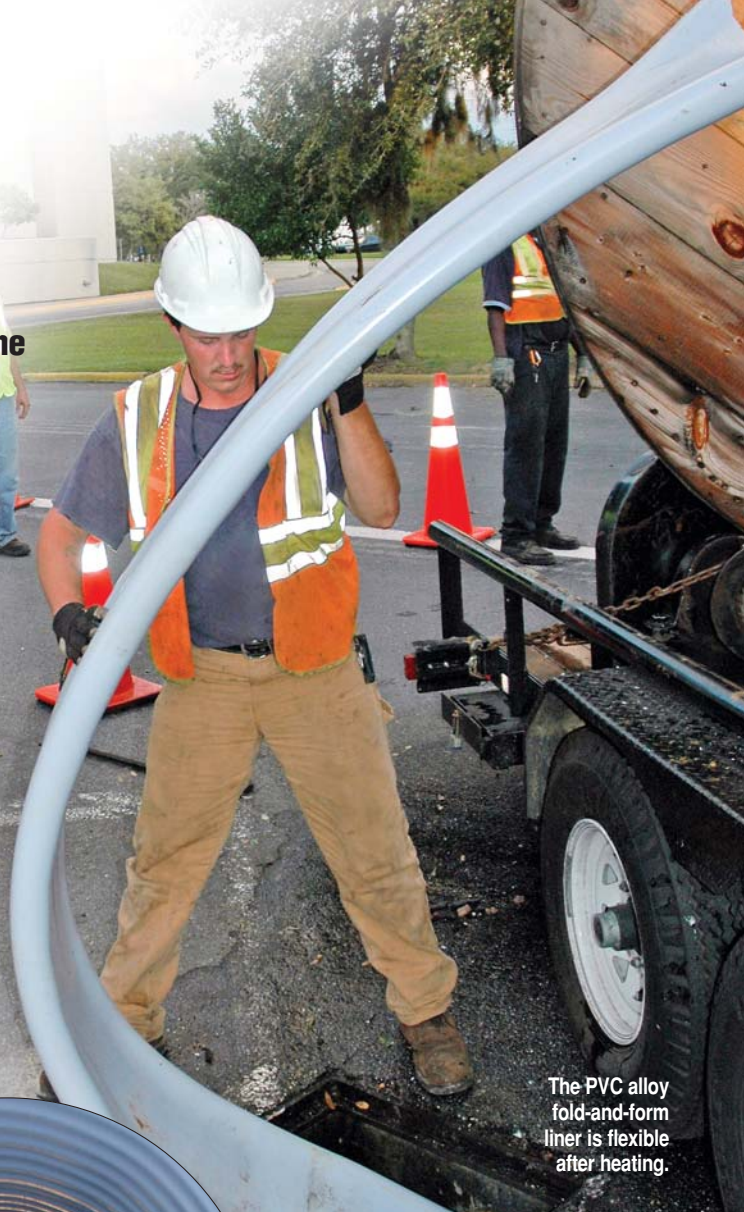
The PVC alloy fold-and-form liner is flexible after heating.

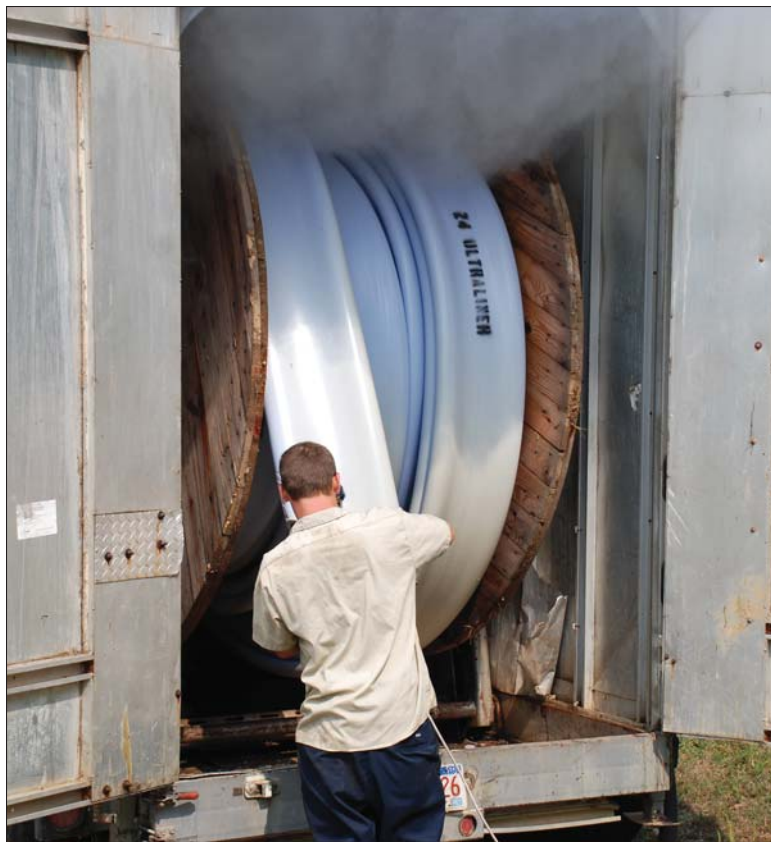
Above, the liner is heated with steam to prepare it for installation. Below left, the liner is pulled into a storm drain.

Pender notes that the liners could not simply be pulled off the spools because the alloy has a memory, and it coils up again. The material must be heated and softened first. The spool was loaded into a hotbox, where steam from a boiler truck was introduced through a pipe into the center of the spool. The hole, acting like a chimney, dispersed steam at 280 degrees F upward and over the liner.
