A composite manhole replaces a manhole approaching failure in a lightly used turn lane. (Photos courtesy of Gwinnett County Public Utilities)

### BETTER MOUSETRAPS

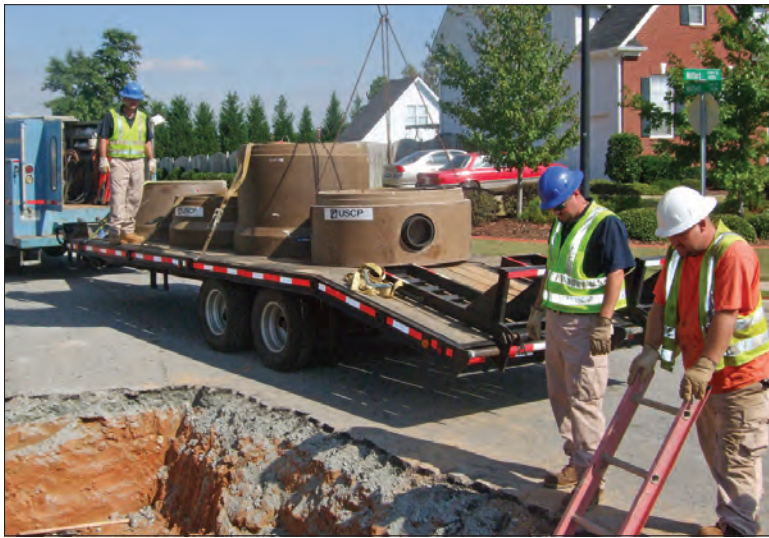
**Gwinnett County workers prepare to install the sections of a composite manhole.**

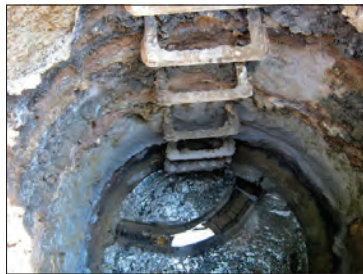
**LEFT: Hydrogen sulfide ate through an epoxy lining and attacked the concrete manhole. RIGHT: Hydrogen sulfide corrosion in a 6-inch force main. A worker's shovel went straight through the main during excavation.**

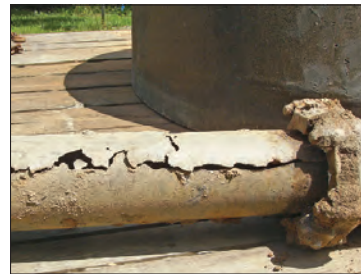
### Professionals at work
