## BETTER MOUSETRAPS

# PLUGGING THE GAPS

An epoxy coating system helps a Florida sewer department cut off I&I from manholes and drive down sanitary sewer overflows

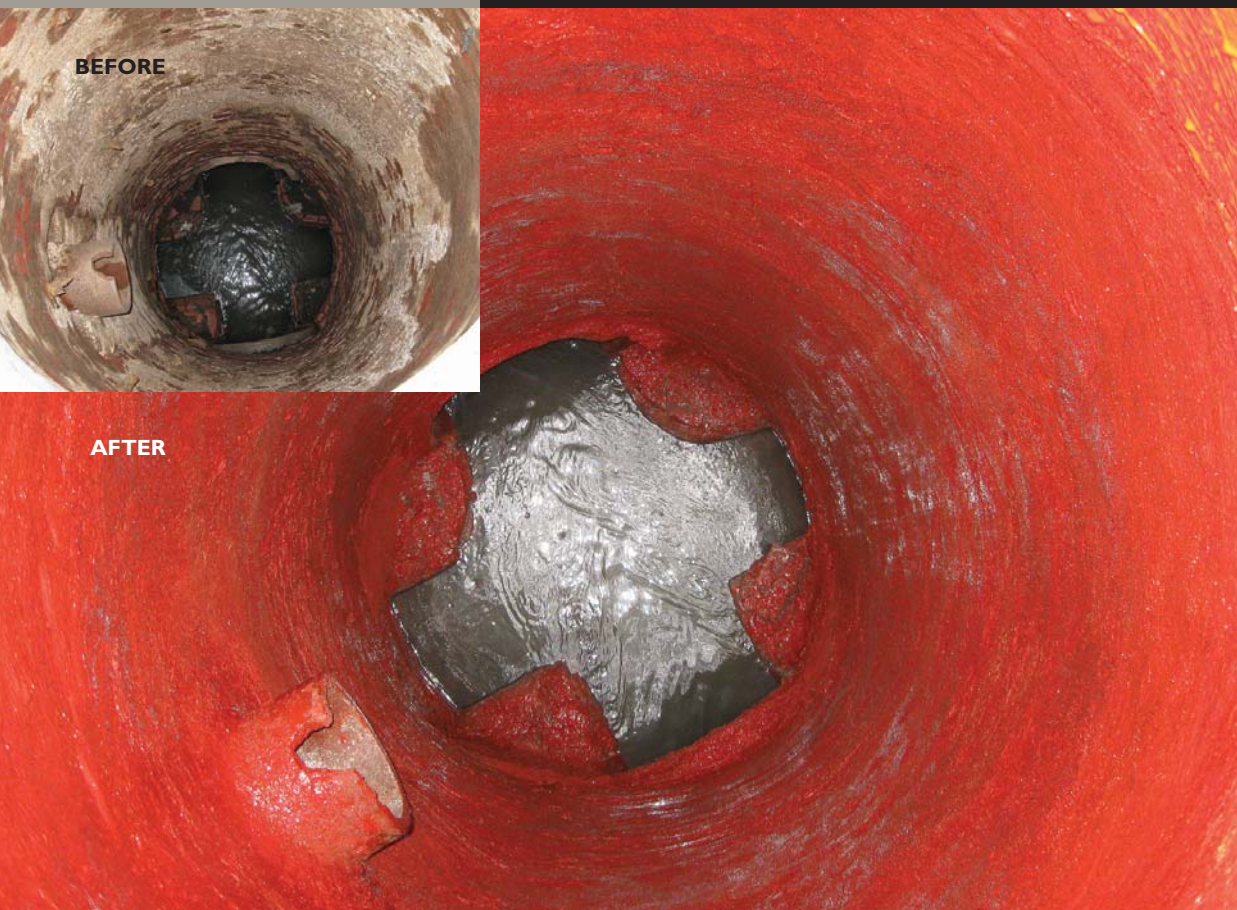
A manhole is shown before and after lining with the epoxy coating system. (Photos courtesy Wastewater Collection Division, Miami-Dade Water and Sewer Department)

The Uroflex coating, applied with a paint roller, adheres to the concrete substrate even if moisture is present. It dries in 30 minutes. A three-man crew can rehabilitate an average manhole in four to five hours.

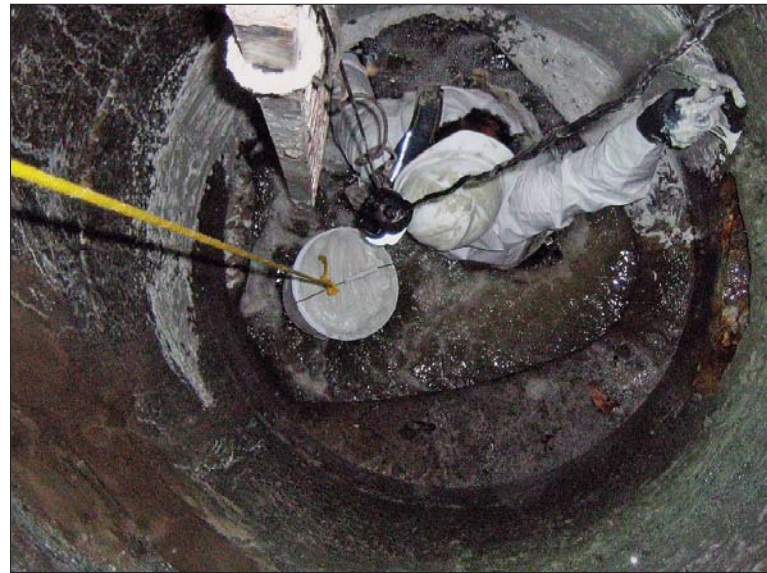
**Confined-space entry gear protects a worker from contacting the concrete polymer paste as he trowels it into voids and restores the manhole to its original contour.**

The CPP, applied with a trowel to fill voids or restore the manhole to its original contour, dries in 30 minutes. The manhole walls do not have to be dry before the CPP is applied. "Having moisture-tolerant products is very important because of the damp environment in sewers," says Lovett.

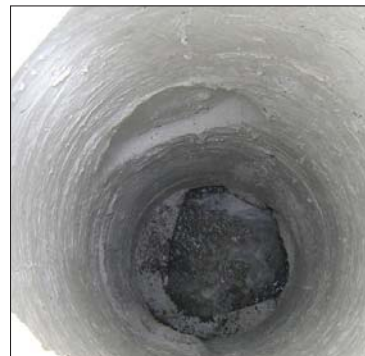
**The concrete polymer paste restores manholes by filling voids. This manhole is ready for coating.**
